**Flood Control Project Maintenance  
Levee Inspections**

**2014 Channel Summary Report**

**Madera County FCWCA**

**Levee Inspection Report By Mile - Channel 2014**

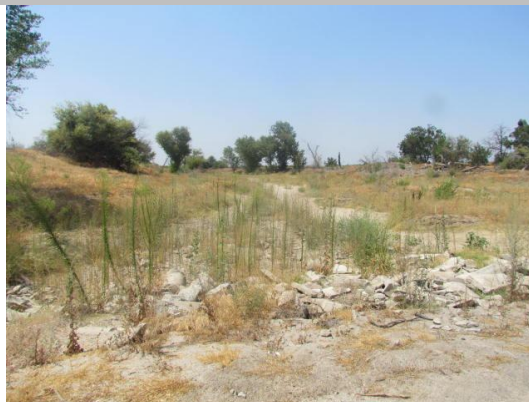
Photo 1 of 1 : CH\_2014\_NA0011\_38\_56\_20140818\_00029.jpg

Inspector Comments: No vegetation or obstruction present to impeded channel flow.

Looking west (downstream) at channel from Road 12.

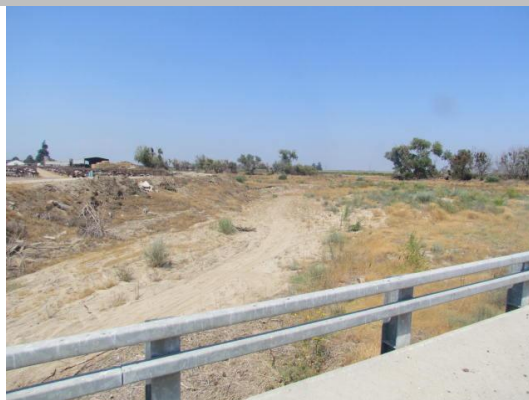
Photo 1 of 1 : CH\_2014\_NA0011\_38\_61\_20140818\_00030.jpg

Check Point / View				
<b>Ave 23 1/2 / Up</b>				
Rating **	A	Issue No.	<b>61</b>	GPS Lat/Long
Issue Type +	Ma	Location *		37.090920 °
Category	Rivers, Channels & Designated Flood			-120.268370 °
Item	Vegetation & Obstructions			
DWR ID	DWR_NA0011_38_c_2012_61			
Action/Comments				
Inspector Comments: No vegetation or obstruction present to impeded channel flow.

Looking east (upstream) at channel from Avenue 23 1/2.

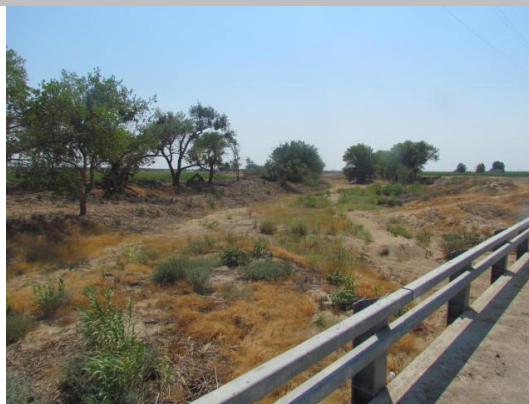
Photo 1 of 1 : CH\_2014\_NA0011\_38\_66\_20140818\_00031.jpg

Rating **	A	Issue No.	66	GPS Lat/Long
Issue Type +	Ma	Location *		37.090920 °
Category	Rivers, Channels & Designated Flood			-120.268370 °
Item	Vegetation & Obstructions			
DWR ID	DWR_NA0011_38_c_2012_66			
Action/Comments				
Inspector Comments: No vegetation issues.

Looking west (downstream) at channel from Avenue 23 1/2.

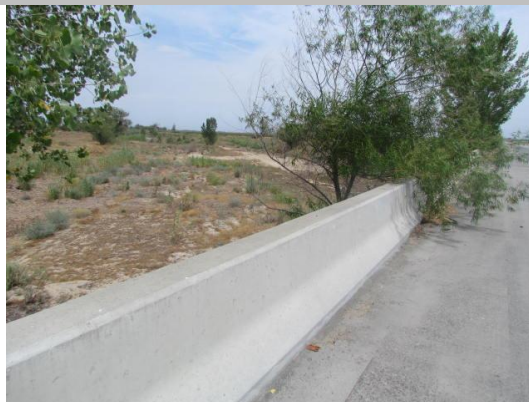
Photo 1 of 1 : CH\_2014\_NA0011\_38\_71\_20140710\_00014.jpg

Inspector Comments: A minimal amount of vegetation near the bridge that should be controlled, but does not impede channel flow.

Looking east (upstream) at channel from Hwy 152.

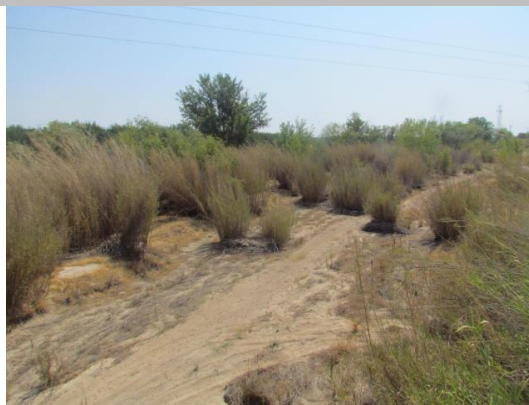
Photo 1 of 1 : CH\_2014\_NA0011\_38\_76\_20140818\_00032.jpg

Check Point / View				
<b>Hwy 152 / Down</b>				
Rating **	A	Issue No.	<b>76</b>	GPS Lat/Long
Issue Type +	Ma	Location *		37.083010 °
Category	Rivers, Channels & Designated Flood			-120.361040 °
Item	Vegetation & Obstructions			
DWR ID	DWR_NA0011_38_c_2012_76			
Action/Comments				
Inspector Comments: Bamboo near bridge should be controlled.

Looking west (downstream) at channel from Hwy 152.

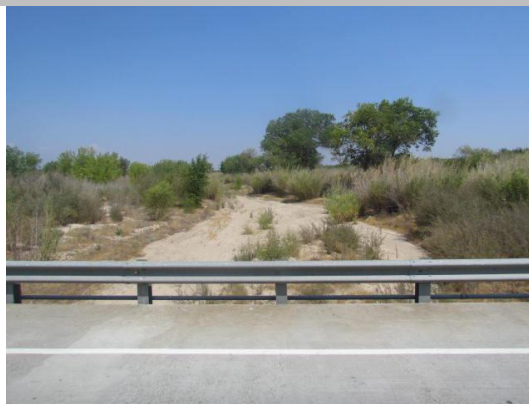
Photo 1 of 1 : CH\_2014\_NA0011\_38\_81\_20140818\_00033.jpg

Rating **	A	Issue No.	81	GPS Lat/Long
Issue Type +	Ma	Location *		37.077870 °
Category	Rivers, Channels & Designated Flood			-120.382770 °
Item	Vegetation & Obstructions			
DWR ID	DWR_NA0011_38_c_2012_81			
Action/Comments				
Inspector Comments: No vegetation or obstructions present to impede channel flow.

Looking east (upstream) at channel from Road 9.

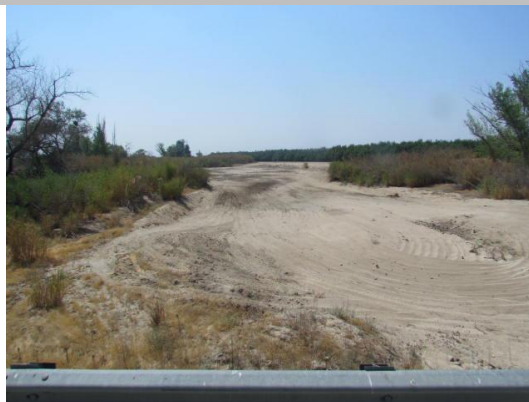
Photo 1 of 1 : CH\_2014\_NA0011\_38\_86\_20140818\_00034.jpg

Inspector Comments: No vegetation or obstructions present to impede channel flow.

Looking west (downstream) at channel from Road 9.

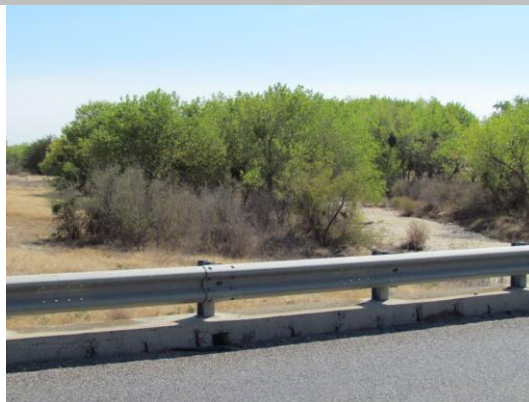
Photo 1 of 1 : CH\_2014\_NA0011\_39\_31\_20140815\_00033.jpg

Check Point / View				
<b>Chowchilla Blvd / Up</b>				
Rating **	A	Issue No.	31	GPS Lat/Long
Issue Type +	Ma	Location *		37.106480 °
Category	Rivers, Channels & Designated Flood			-123.234211 °
Item	Vegetation & Obstructions			
DWR ID	DWR_NA0011_39_c_2012_31			
Action/Comments

Berenda Slough looking upstream from the Chowchilla Blvd. crossing.

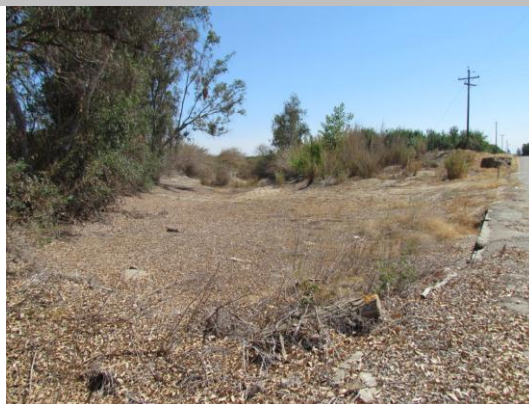
Photo 1 of 1 : CH\_2014\_NA0011\_39\_61\_20140815\_00039.jpg

Inspector Comments: There is growth in channel, flow will not be impeded. There is bamboo in channel that has been cut down.

Berenda Slough from Ave. 22.

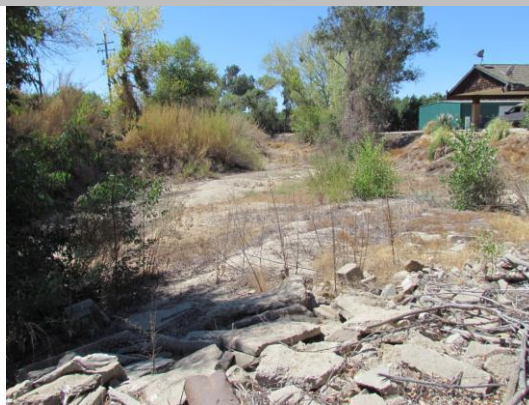
Photo 1 of 1 : CH\_2014\_NA0011\_39\_66\_20140815\_00040.jpg

Check Point / View				
<b>Ave 22 / Down</b>				
Rating **	M	Issue No.	66	GPS Lat/Long
Issue Type +	Ma	Location *		37.068580 °
Category	Rivers, Channels & Designated Flood			-120.397780 °
Item	Vegetation & Obstructions			
DWR ID	DWR_NA0011_39_c_2012_66			
Action/Comments				
Inspector Comments: Minimal, scattered obstructions or vegetation. The flow is not impeded.

Berenda Slough At Avenue 22 crossing.

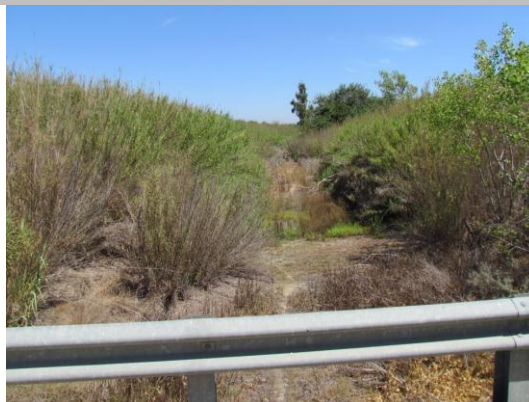
Photo 1 of 1 : CH\_2014\_NA0011\_39\_116\_20140815\_00042.jpg

Check Point / View				
<b>Ave 21 / Down</b>				
Rating **	U	Issue No.	116	GPS Lat/Long
Issue Type +	Ma	Location *		37.054470 °
Category	Rivers, Channels & Designated Flood			-120.284380 °
Item	Vegetation & Obstructions			
DWR ID	DWR_NA0011_39_c_2012_116			
Action/Comments				
Inspector Comments: Log jams, snags, vegetation growth (such as cat tails, bull rushes, bushes or saplings) or other obstructions block approximately 25% of the FCW.

Berenda Slough looking downstream from Avenue 21.

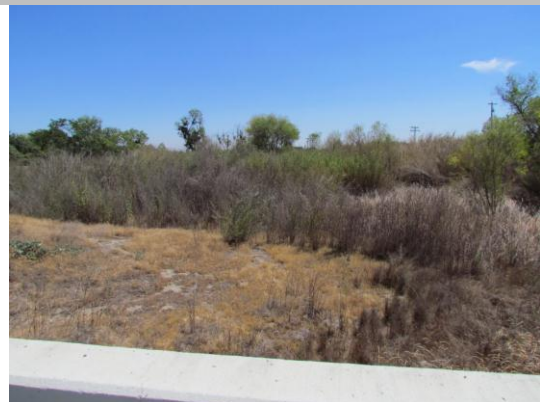
Photo 1 of 1 : CH\_2014\_NA0011\_39\_81\_20140819\_00044.jpg

Check Point / View				
<b>Rd 13 / Up</b>				
Rating **	U	Issue No.	81	GPS Lat/Long
Issue Type +	Ma	Location *		37.025350 °
Category	Rivers, Channels & Designated Flood			-120.310510 °
Item	Vegetation & Obstructions			
DWR ID	DWR_NA0011_39_c_2012_81			
Action/Comments				
Inspector Comments: Log jams, snags, vegetation growth (such as cat tails, bull rushes, bushes or saplings) or other obstructions block approximately 50% of the FCW.

Berenda Slough at Road 13 crossing.

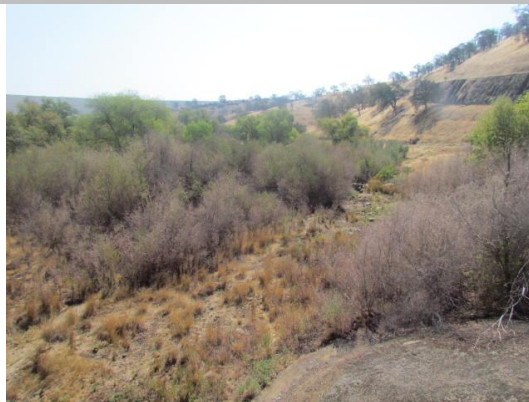
Photo 1 of 1 : CH\_2014\_NA0011\_40\_1\_20140818\_00025.jpg

Inspector Comments: No vegetation or obstructions present that would impede the flow.

Looking east (upstream) at channel downstream from Dam.

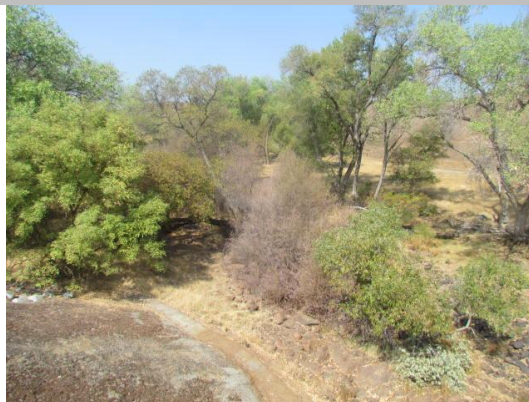
Photo 1 of 1 : CH\_2014\_NA0011\_40\_2\_20140818\_00026.jpg

Check Point / View				
<b>Downstream Buchanan Dam / Down</b>				
Rating **	A	Issue No.	2	GPS Lat/Long
Issue Type +	Ma	Location *		-121.215880 °
Category	Rivers, Channels & Designated Flood			119.991490 °
Item	Vegetation & Obstructions			
DWR ID	DWR_NA0011_40_c_2012_2			
Action/Comments				
Inspector Comments: No vegetation or obstructions present that would impede the flow.

Looking west (downstream) at channel downstream from Dam (Road 29).

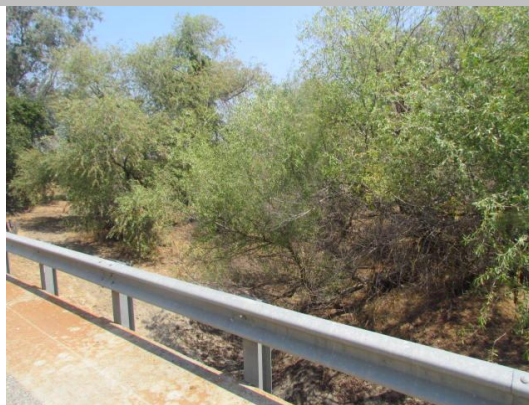
Photo 1 of 1 : CH\_2014\_NA0011\_40\_3\_20140818\_00027.jpg

Rating **	A	Issue No.	3	GPS Lat/Long
Issue Type +	Ma	Location *		37.164710 °
Category	Rivers, Channels & Designated Flood			-120.174880 °
Item	Vegetation & Obstructions			
DWR ID	DWR_NA0011_40_c_2012_3			
Action/Comments				
Inspector Comments: Trees established in channel near bridge should be removed for better view of channel.

Looking east (upstream) at channel from Santa Fe Dr.

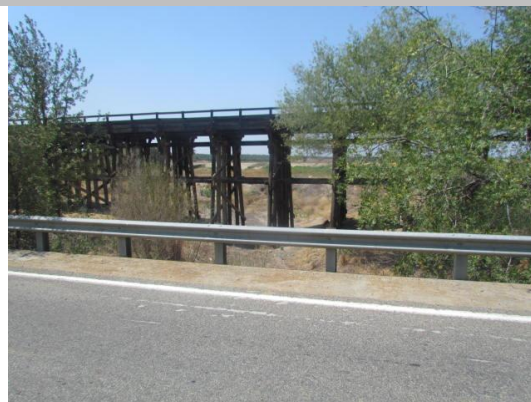
Photo 1 of 1 : CH\_2014\_NA0011\_40\_5\_20140818\_00028.jpg

Rating **	M	Issue No.	5	GPS Lat/Long
Issue Type +	Ma	Location *		37.164710 °
Category	Rivers, Channels & Designated Flood			-120.174880 °
Item	Vegetation & Obstructions			
DWR ID	DWR_NA0011_40_c_2012_5			
Action/Comments				
Inspector Comments: Control tree growth in channel near bridge.

Looking west (downstream) at channel from Santa Fe Dr.

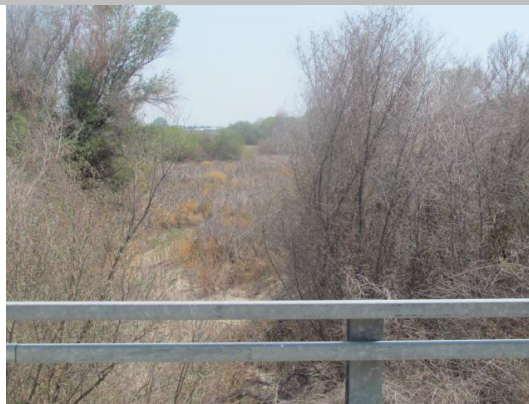
Photo 1 of 1 : CH\_2014\_NA0011\_40\_9\_20140818\_00029.jpg

Inspector Comments: Established trees near bridge should be controlled.

Looking east (upstream) at channel from White Rock Road.

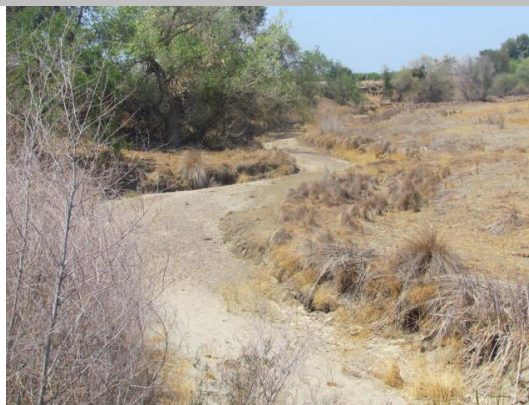
Photo 1 of 1 : CH\_2014\_NA0011\_40\_12\_20140818\_00030.jpg

Check Point / View				
White Rock Rd / Down				
Rating **	A	Issue No.	12	GPS Lat/Long
Issue Type +	Ma	Location *		37.161820°
Category	Rivers, Channels & Designated Flood			-120.202050°
Item	Vegetation & Obstructions			
DWR ID	DWR_NA0011_40_c_2012_12			
Action/Comments				
Inspector Comments: Minimal vegetation or obstructions present that should not impede the flow.

Looking west (downstream) at channel from White Rock Road.

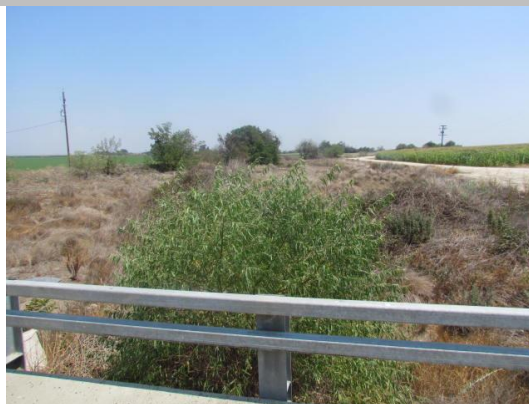
Photo 1 of 1 : CH\_2014\_NA0011\_40\_21\_20140818\_00031.jpg

Inspector Comments: No vegetation issues present.

Looking east (upstream) at channel from Road 13.

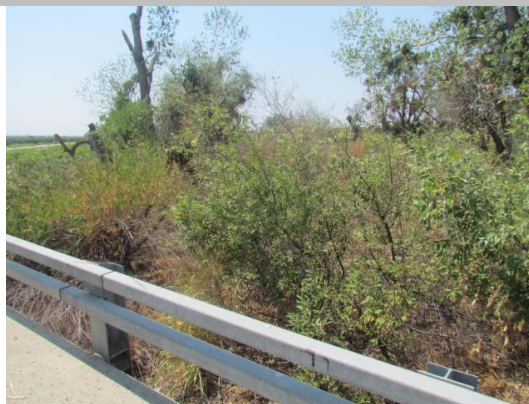
Photo 1 of 1 : CH\_2014\_NA0011\_40\_24\_20140818\_00033.jpg

Rating **	M	Issue No.	24	GPS Lat/Long
Issue Type +	Ma	Location *		37.140600 °
Category	Rivers, Channels & Designated Flood			-120.310110 °
Item	Vegetation & Obstructions			
DWR ID	DWR_NA0011_40_c_2012_24			
Action/Comments				
Inspector Comments: Established trees and vegetation near bridge should be removed.

Looking west (downstream) from Road 13.

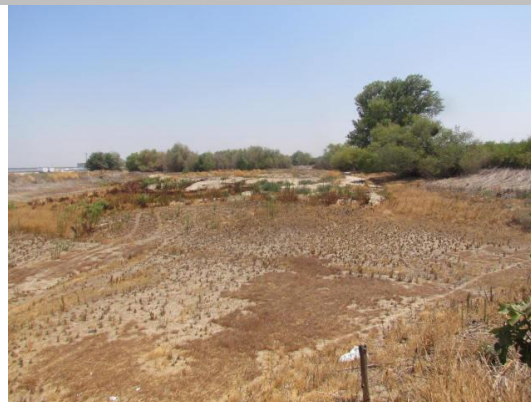
Photo 1 of 2 : CH\_2014\_NA0011\_40\_15\_20140818\_00034.jpg

Check Point / View				
<b>RD 15 / Up</b>				
Rating **	A	Issue No.	15	GPS Lat/Long
Issue Type +	Ma	Location *		37.151660 °
Category	Rivers, Channels & Designated Flood			-120.274370 °
Item	Vegetation & Obstructions			
DWR ID	DWR_NA0011_40_c_2012_15			
Action/Comments				
Inspector Comments: No vegetation issues present.

Looking east (upstream) at channel from Road 15. (2014)

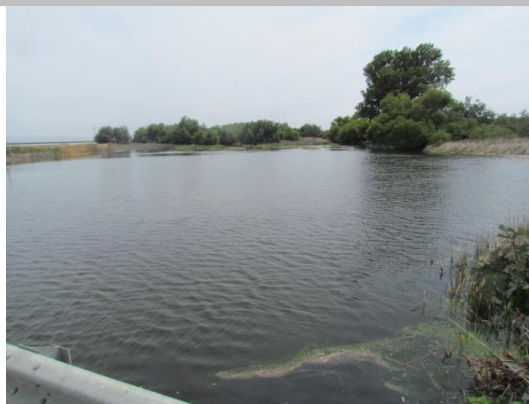
Photo 2 of 2 : CH\_2014\_NA0011\_40\_15\_20140710\_00009.jpg

Check Point / View				
RD 15 / Up (cont)				
Rating **	A	Issue No.	15 (cont)	GPS Lat/Long
Issue Type +	Ma	Location *		37.151660 °
Category	Rivers, Channels & Designated Flood			-120.274370 °
Item	Vegetation & Obstructions			
DWR ID	DWR_NA0011_40_c_2012_15			
Action/Comments				
Inspector Comments: No vegetation issues present.

Looking east (upstream) at channel from Road 15. (2013)

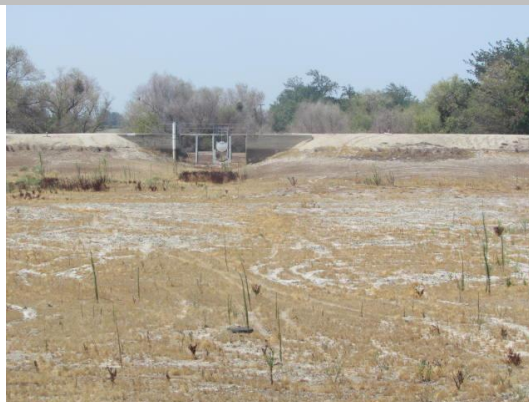
Photo 1 of 1 : CH\_2014\_NA0011\_40\_18\_20140818\_00035.jpg

Inspector Comments: No vegetation or obstructions present to impede flow.

Looking west (downstream) at Check Dam from Road 15.

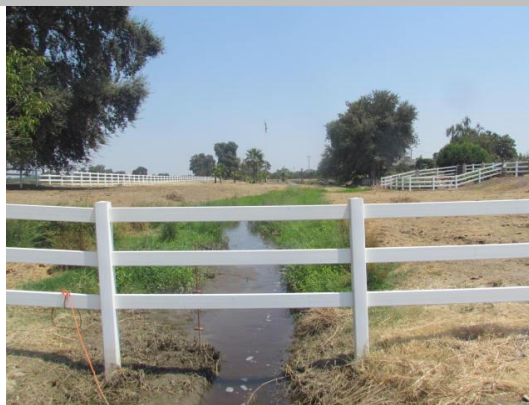
Photo 1 of 1 : CH\_2014\_NA0011\_40\_27\_20140818\_00036.jpg

Check Point / View				
<b>Low Water Crossing at Rd 11 / Up</b>				
Rating **	A	Issue No.	27	GPS Lat/Long
Issue Type +	Ma	Location *		37.123770 °
Category	Rivers, Channels & Designated Flood			-120.347120 °
Item	Vegetation & Obstructions			
DWR ID	DWR_NA0011_40_c_2012_27			
Action/Comments				
Inspector Comments: No vegetation or obstruction that would impede the flow present.

Looking east (upstream) at channel from Road 11.

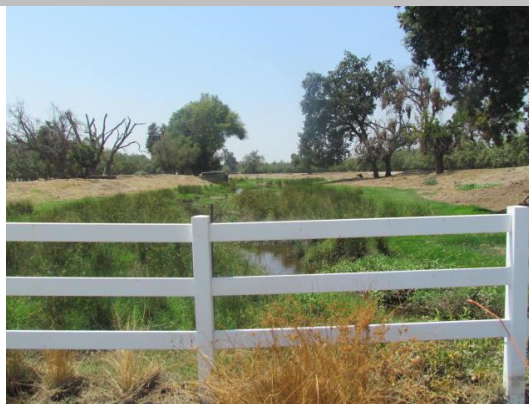
Photo 1 of 2 : CH\_2014\_NA0011\_40\_30\_20140818\_00037.jpg

Rating **	A	Issue No.	30	GPS Lat/Long
Issue Type +	Ma	Location *		37.123770 °
Category	Rivers, Channels & Designated Flood			-120.347120 °
Item	Vegetation & Obstructions			
DWR ID	DWR_NA0011_40_c_2012_30			
Action/Comments				
Inspector Comments: No vegetation or obstructions present to impede flow.

Looking west (downstream) at channel from Road 11. (2014)

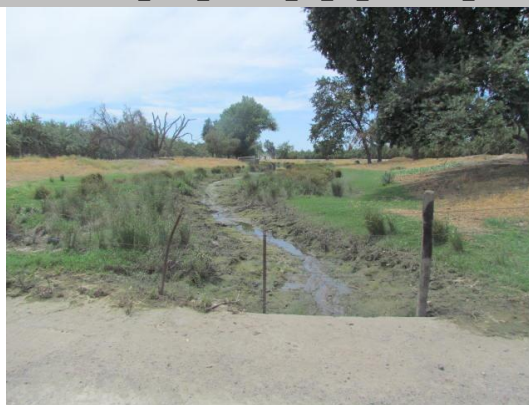
Photo 2 of 2 : CH\_2014\_NA0011\_40\_30\_20140710\_00015.jpg

Looking west (downstream) at channel from Road 11. (2013)

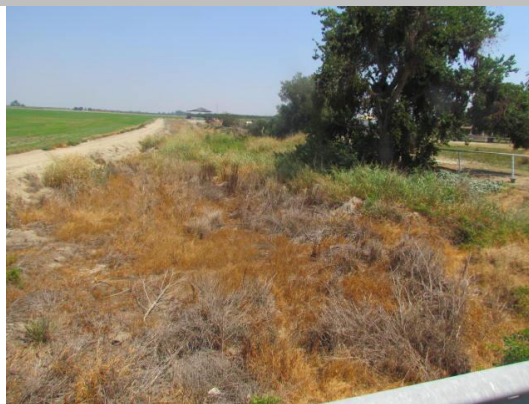
Photo 1 of 1 : CH\_2014\_NA0011\_40\_39\_20140818\_00038.jpg

Rating **	A	Issue No.	39	GPS Lat/Long
Issue Type +	Ma	Location *		37.124145 °
Category	Rivers, Channels & Designated Flood			-120.382724 °
Item	Vegetation & Obstructions			
DWR ID	DWR_NA0011_40_c_2012_39			
Action/Comments				
Inspector Comments: Minor vegetation present the flow is not impeded.

Looking east (upstream) at channel from Road 9.

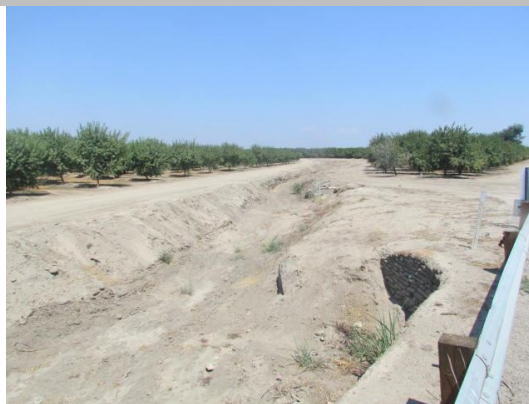
Photo 1 of 1 : CH\_2014\_NA0011\_40\_33\_20140818\_00040.jpg

Check Point / View				
Ave 25 & Washington Rd / Up				
Rating **	A	Issue No.	33	GPS Lat/Long
Issue Type +	Ma	Location *		37.112750 °
Category	Rivers, Channels & Designated Flood			-120.405860 °
Item	Vegetation & Obstructions			
DWR ID	DWR_NA0011_40_c_2012_33			
Action/Comments				
Inspector Comments: No vegetation or obstructions present to impede channel flow.

Looking east (upstream) at channel from Avenue 25 & Washington Road.

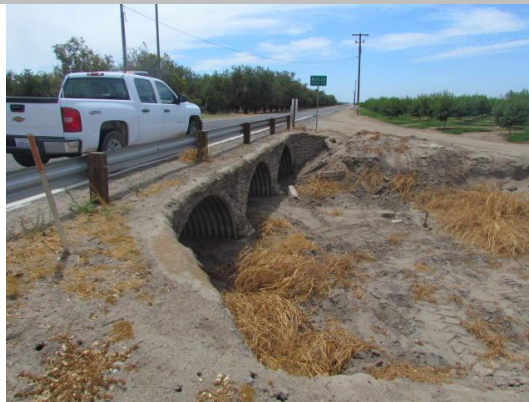
Photo 1 of 2 : CH\_2014\_NA0011\_40\_34\_20140710\_00017.jpg

Inspector Comments: Sediment in front of culverts has been removed.

Looking north at culverts crossing Avenue 25 & Washington Road.

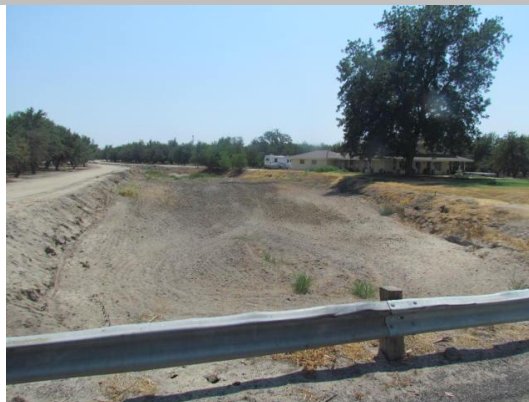
Photo 1 of 1 : CH\_2014\_NA0011\_40\_36\_20140818\_00041.jpg

Check Point / View				
<b>Ave 25 &amp; Washington Rd / Down</b>				
Rating **	A	Issue No.	36	GPS Lat/Long
Issue Type +	Ma	Location *		37.112750 °
Category	Rivers, Channels & Designated Flood			-120.405860 °
Item	Vegetation & Obstructions			
DWR ID	DWR_NA0011_40_c_2012_36			
Action/Comments				
Inspector Comments: No vegetation or obstructions present to impede channel flow.

Looking west (downstream) at channel from Avenue 25 &amp; Washington Road.

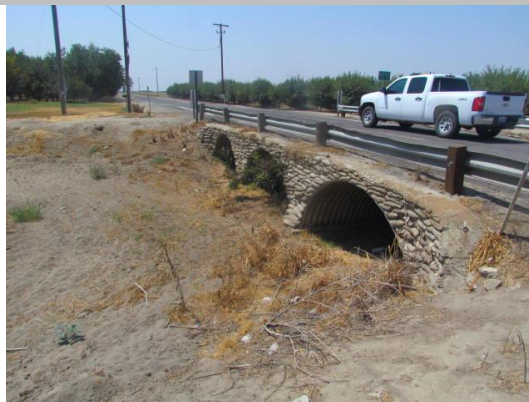
Photo 1 of 1 : CH\_2014\_NA0011\_40\_37\_20140818\_00042.jpg

Rating **	A	Issue No.	37	GPS Lat/Long
Issue Type +	Ma	Location *		37.112750 °
Category	Rivers, Channels & Designated Flood			-120.405860 °
Item	Shoaling / Sedimentation			
DWR ID	DWR_NA0011_40_c_2012_37			
Action/Comments				
Inspector Comments: No shoaling or sedimentation present.

Looking north at cluverts on west side of Avenue 25 & Washington Rd.

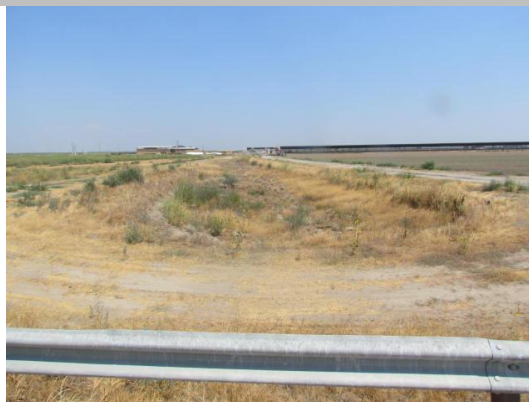
Photo 1 of 1 : CH\_2014\_NA0011\_40\_45\_20140818\_00043.jpg

Check Point / View				
Shultz Rd & Rd 5 1/2 / Up				
Rating **	A	Issue No.	45	GPS Lat/Long
Issue Type +	Ma	Location *		37.101570 °
Category	Rivers, Channels & Designated Flood			-120.446260 °
Item	Vegetation & Obstructions			
DWR ID	DWR_NA0011_40_c_2012_45			
Action/Comments				
Inspector Comments: No vegetation or obstructions present to impede flow.

Looking east (upstream) at channel from Shultz Road.

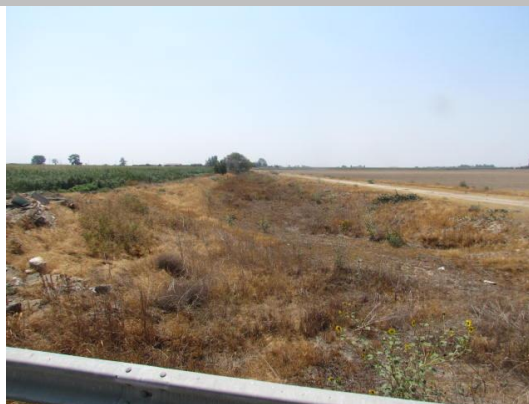
Photo 1 of 1 : CH\_2014\_NA0011\_40\_48\_20140818\_00044.jpg

Inspector Comments: Minimal amount of vegetation that should not impede channel flow.

Looking west (downstream) at channel from Shultz Rd.

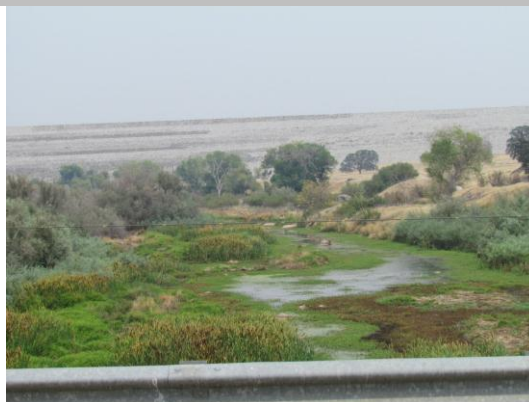
Photo 1 of 1 : CH\_2014\_NA0011\_41\_1\_20140731\_00018.jpg

Inspector Comments: Very little vegetation in the channel upstream side of bridge crossing.

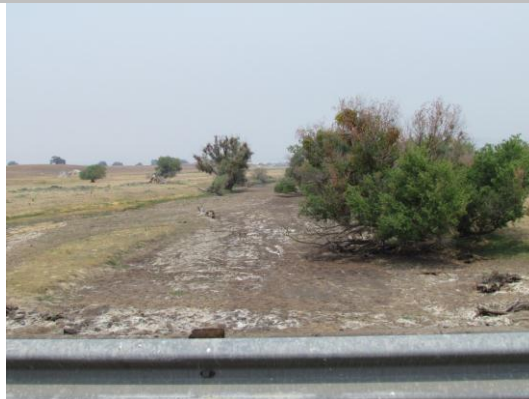
Photo 1 of 1 : CH\_2014\_NA0011\_41\_11\_20140731\_00019.jpg

Inspector Comments: No vegetation in channel upstream of Timber Bridge.

Standing on the Timber Bridge crossing the Fresno River looking upstream.

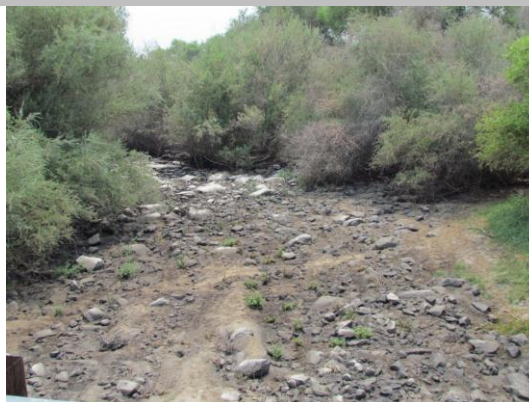
Photo 1 of 1 : CH\_2014\_NA0011\_41\_16\_20140731\_00020.jpg

Rating **	M	Issue No.	16	GPS Lat/Long
Issue Type +	Ma	Location *		37.070110 °
Category	Rivers, Channels & Designated Flood			-119.910220 °
Item	Vegetation & Obstructions			
DWR ID	DWR_NA0011_41_c_2012_16			
Action/Comments				
Inspector Comments: The vegetation present in channel does not obstruct flow under the bridge.

Looking downstream from the Timber bridge crossing Fresno River. No water in channel. Wild growth of trees downstream of bridge.

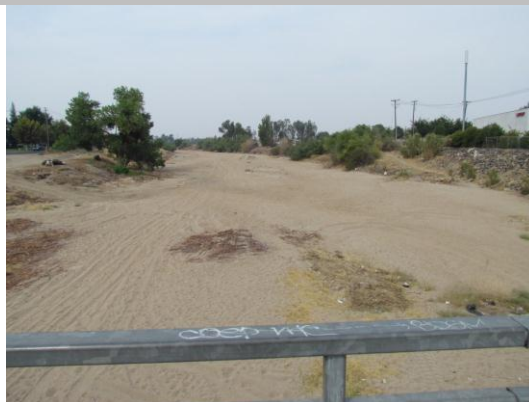
Photo 1 of 1 : CH\_2014\_NA0011\_41\_21\_20140731\_00021.jpg

Rating **	A	Issue No.	21	GPS Lat/Long
Issue Type +	Ma	Location *		36.974320 °
Category	Rivers, Channels & Designated Flood			-120.043320 °
Item	Vegetation & Obstructions			
DWR ID	DWR_NA0011_41_c_2012_21			
Action/Comments				
Inspector Comments: Minimal, scattered obstructions or vegetation. The flow is not impeded. The channel is dry at this crossing.

Fresno River looking upstream from Cleveland Ave. crossing.

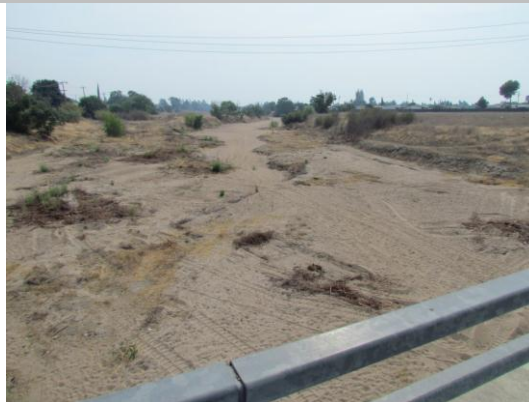
Photo 1 of 1 : CH\_2014\_NA0011\_41\_26\_20140812\_00022.jpg

Inspector Comments: Minimal scattered obstructions or vegetation. The flow is not impeded.

Fresno River from Cleveland Avenue bridge looking downstream.

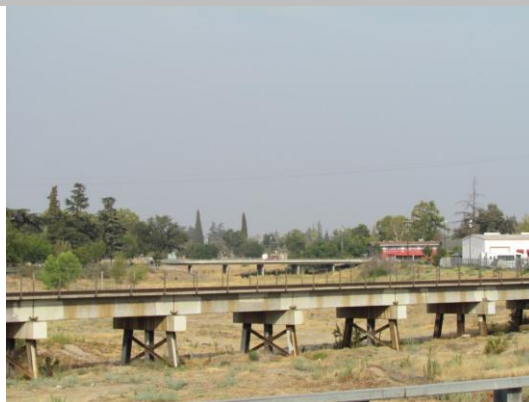
Photo 1 of 1 : CH\_2014\_NA0011\_41\_31\_20140812\_00023.jpg

Rating **	A	Issue No.	31	GPS Lat/Long
Issue Type +	Ma	Location *		36.968760 °
Category	Rivers, Channels & Designated Flood			-120.067840 °
Item	Vegetation & Obstructions			
DWR ID	DWR_NA0011_41_c_2012_31			
Action/Comments				
Inspector Comments: Minimal, scattered obstructions or vegetation. The flow is not impeded.

Fresno River from Gateway crossing looking upstream of channel.

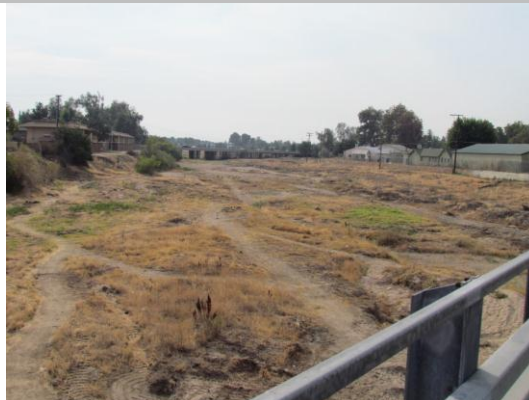
Photo 1 of 1 : CH\_2014\_NA0011\_41\_36\_20140812\_00024.jpg

Inspector Comments: Minimal, scattered obstructions or vegetation. The flow is not impeded.

Fresno River from Gateway Bridge crossing looking downstream, open channel.

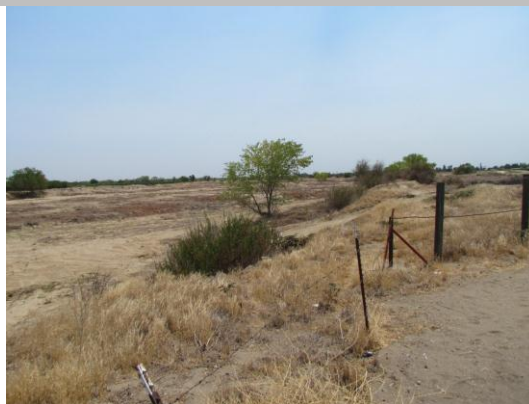
Photo 1 of 1 : CH\_2014\_NA0011\_41\_51\_20140813\_00028.jpg

Rating **	A	Issue No.	51	GPS Lat/Long
Issue Type +	Ma	Location *		36.967900 °
Category	Rivers, Channels & Designated Flood			-120.128770 °
Item	Vegetation & Obstructions			
DWR ID	DWR_NA0011_41_c_2012_51			
Action/Comments				
Inspector Comments: Minimal scattered growth of vegetation in channel, the flow is not impeded.

Fresno River crossing looking upstream from Road 23.

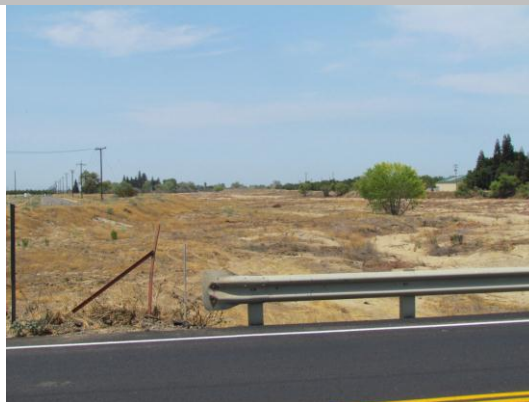
Photo 1 of 1 : CH\_2014\_NA0011\_41\_56\_20140813\_00029.jpg

Check Point / View				
<b>Rd 23 / Down</b>				
Rating **	A	Issue No.	56	GPS Lat/Long
Issue Type +	Ma	Location *		36.967900 °
Category	Rivers, Channels & Designated Flood			-120.128770 °
Item	Vegetation & Obstructions			
DWR ID	DWR_NA0011_41_c_2012_56			
Action/Comments				
Inspector Comments: No vegetation in channel.

Fresno River looking downstream from bridge crossing, clear channel.

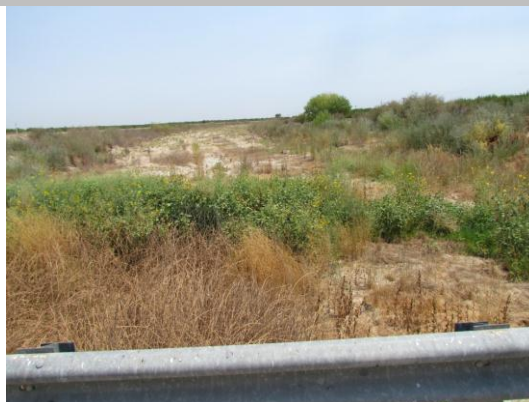
Photo 1 of 1 : CH\_2014\_NA0011\_41\_61\_20140813\_00030.jpg

Check Point / View				
<b>Rd 20 / Up</b>				
Rating **	A	Issue No.	<b>61</b>	GPS Lat/Long
Issue Type +	Ma	Location *		36.982340 °
Category	Rivers, Channels & Designated Flood			-120.184160 °
Item	Vegetation & Obstructions			
DWR ID	DWR_NA0011_41_c_2012_61			
Action/Comments				
Inspector Comments: Minimal, scattered obstructions or vegetation. The flow is not impeded.

Fresno River looking upstream from Road 20 bridge crossing.  
Vegetation present in channel.

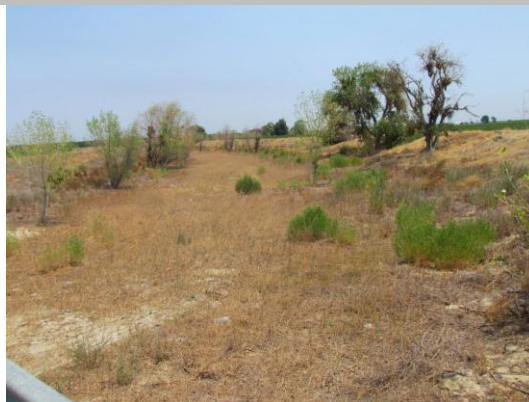
Photo 1 of 1 : CH\_2014\_NA0011\_41\_71\_20140813\_00032.jpg

Check Point / View				
<b>Rd 19, D/S Limit / Up</b>				
Rating **	A	Issue No.	71	GPS Lat/Long
Issue Type +	Ma	Location *		36.972802 °
Category	Rivers, Channels & Designated Flood			-120.211845 °
Item	Vegetation & Obstructions			
DWR ID	DWR_NA0011_41_c_2012_71			
Action/Comments				
Inspector Comments: The County has done a great job of removing materials, wild growth and other unwanted vegetation from the Fresno River channel.

Fresno River looking upstream from Road 19, D/S Limits of the River channel.

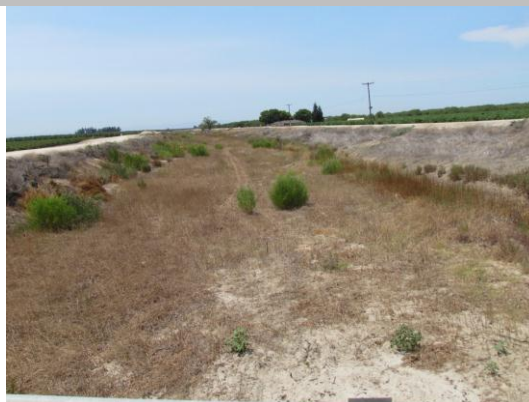
Photo 1 of 2 : CH\_2014\_NA0011\_41\_76\_20140813\_00033.jpg

Rating **	A	Issue No.	76	GPS Lat/Long
Issue Type +	Ma	Location *		36.972802 °
Category	Rivers, Channels & Designated Flood			-120.211845 °
Item	Vegetation & Obstructions			
DWR ID	DWR_NA0011_41_c_2012_76			
Action/Comments				
Inspector Comments: Madera County has done a great job on the channel Maintenance Program that was done late in 2013 along some reaches in the Fresno River.

Fresno River looking downstream from bridge channel recently was cleaned out by the Madera County. Great job.

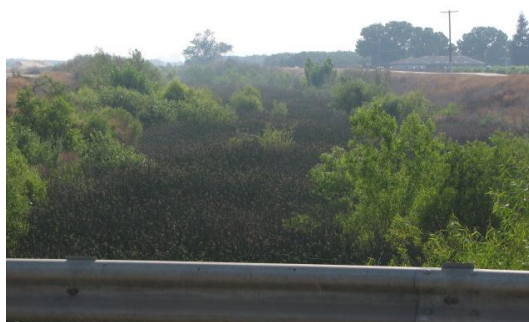
Photo 2 of 2 : CH\_2014\_NA0011\_41\_76\_20140707\_00016.jpg

Inspector Comments: Madera County has done a great job on the channel Maintenance Program that was done late in 2013 along some reaches in the Fresno River.

Fresno River looking downstream from bridge crossing. The channel is choked with wild growth. Photo taken 7-30-2013.
